Manhole Inspection Summary

Manhole # S33A__068MH

Insp Date: **8/19/09 3:13 PM**

Location Address: **PARK AVE**

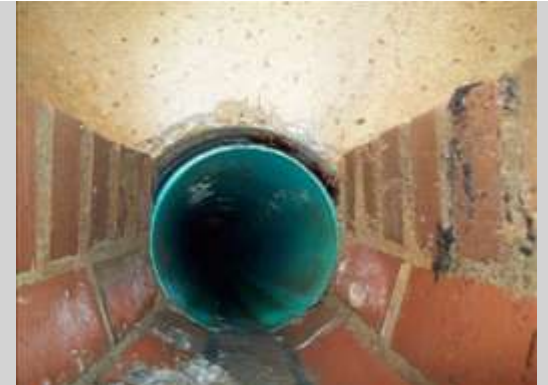
12 O'Clock Outflow

8 in. Circular Gravity Sewer
Pipe Out @ 12 O'Clock

Pipe Material: **PVC** ☐ Pipe Lined

Invert Depth: **5.50** (ft.) Flow Characteristics: **None**

Deposits: ☒ None ☐ Mud ☐ Sludge ☐ Debris ☐ Grease

Infiltration: **None** Pipe Seal Cond: **Sound**

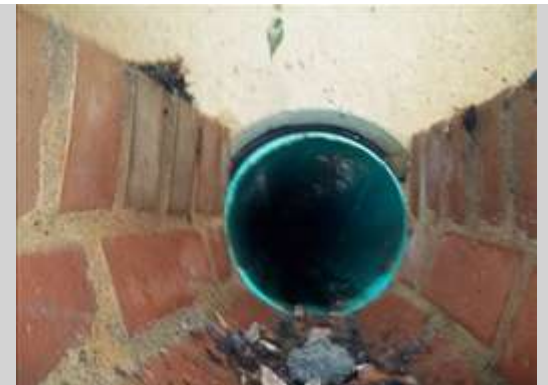
6 O'Clock Inflow

8 in. Circular Gravity Sewer
Pipe In @ 6 O'Clock

Pipe Material: **PVC** ☐ Pipe Lined

Invert Depth: **5.60** (ft.) Flow Characteristics: **None**

Deposits: ☒ None ☐ Mud ☐ Sludge ☐ Debris ☐ Grease

Infiltration: **None** Pipe Seal Cond: **Sound**
